## Assessment of Urban Flood Disaster: A Case Study of 2011 Ibadan Floods

\*Alayande W. A., Mohammed G., Caleb I. and Deimodei M. I.

Land and Water Division  
National Water Resources Institute, Mando Road. Kaduna

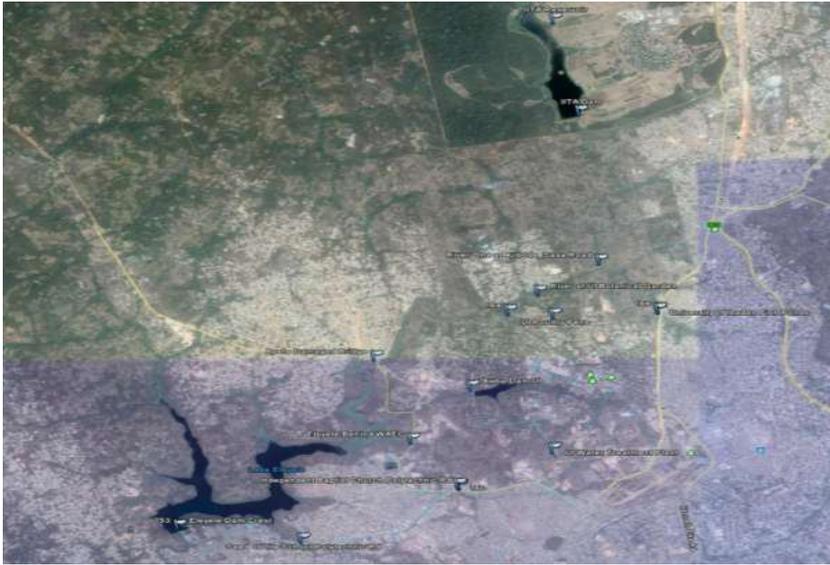
Fig. 2: The three Reservoirs within Study Area. (Google Earth, 2011)

The Ona River and its tributaries drain the western and the northern part of the City in a south western direction. The Awba River a major tributary of the Ona River took its source around Moniya, upstream of the IITA. The IITA dam was constructed on the Awba River in 1967 and provides a dependable source of agricultural and domestic water supply for the entire Research Institute. The Ona River took its source around Bodija, a highly built up elite settlement and flows through Agbowo into the University of Ibadan (UI) where another tributary, Orogun River which drains the Ojoo Area discharges into the Ona River upstream of the confluence of Awba River and Ona River at Ajibode-Sassa road, immediately upstream of the UI Botanical gardens. The UI dam was constructed on a tributary of the Ona River which has its headwaters at Sango. The main Ona River channel was dammed at Eleyele, downstream of the IITA and UI dams, a waterworks was constructed downstream of the dam and had since 1942 provided a dependable source of water supply to Ibadan, producing 37,000m<sup>3</sup>/day of treated water. Fig. 2 shows the three dams and the densely built up areas in the upper catchment of the Ona River and its tributary.

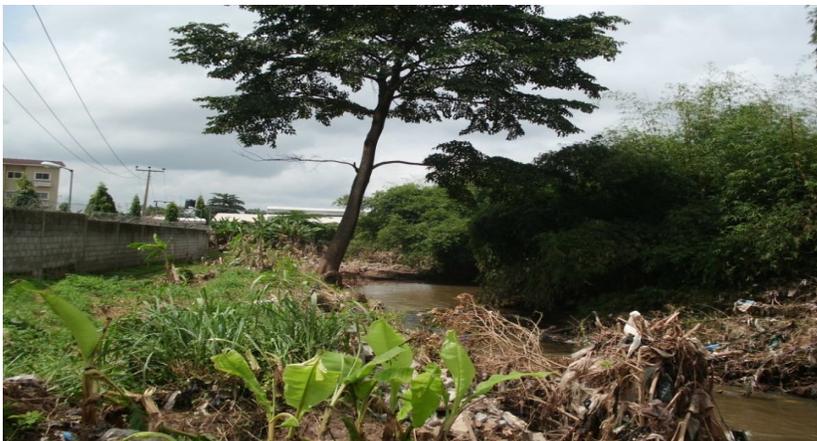
A physical assessment of the upper reach of the river shows a significant part of the flood plain and the river channel has been encroached by housing, commercial and industrial developments. The Channel bed is characteristically flat in most reaches having lost its depth to siltation arising from silts, debris and solid wastes it carries in its flow. The hydraulic implication of this is the loss of river channel's runoff carrying capacity. Of great concern is the presence of thick vegetation comprising of bamboos, typha and elephant grasses and big trees along the river channel as it flows through the City. This help in trapping debris and volume of solid waste in the runoff thereby creating high frictional flow with attendant high time of concentration. In the event of high rainfall like the one experienced on August 26, 2011, the channel capacity easily become overwhelmed resulting in the flooding of its floodplain and adjoining properties. Figure 2 presents the situation of the Ona River Channel at Oluyole Estate.

Fig. 2: Ona River Channel at Oluyole Estate Ibadan

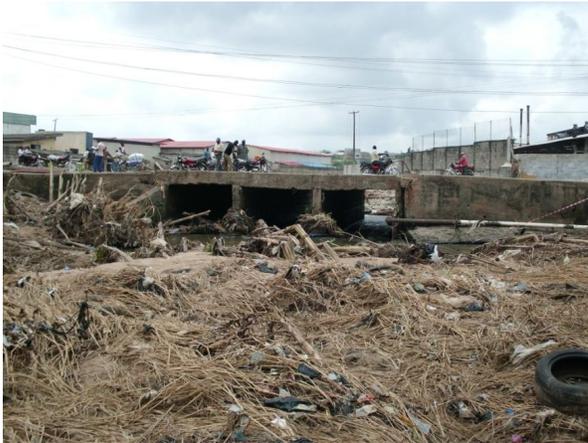
Solid waste collection and disposal system in the City are poorly managed. According to Onibokun & Kumuyi 1999, Sangodoyin 1991, Olaseha & Sridhar 2004, Adenji & Ogundiji 2009, and Olaseha, I. O. and Sridhar, M. K. C. (2004 ) that the solid waste management service in Ibadan are inadequate, with a preponderant proportion of the refuse generated remaining uncollected and with large parts of the city, particularly the low-income areas, receiving little or no attention. The wastes are generally disposed in the storm drainage and river channels, constituting major friction to flow of stormwater in the channel and become trapped at bridges and culvert locations causing over spilling of flood waters at such locations. Figure 3 shows a typical solid waste problem at Oluyole Estate Ibadan.

Fig. 3: Solid Waste Blockage at The Culvert Entrance at Oluyole Estate

- b. An efficient waste management system including engineering landfills must be put in place against the backgrounds of the environmental circumstances of Ibadan. The poor waste management in the City may account for the situation that thirty one years after the "Omiyale" of 31<sup>st</sup> August 1980, a re-enactment of it occurred again on 26<sup>th</sup> August 2011 despite the channelization efforts of the Ogunpa. This is because government after government did not prioritize efficient solid waste management in the capital City, thereby facilitating flood disasters.

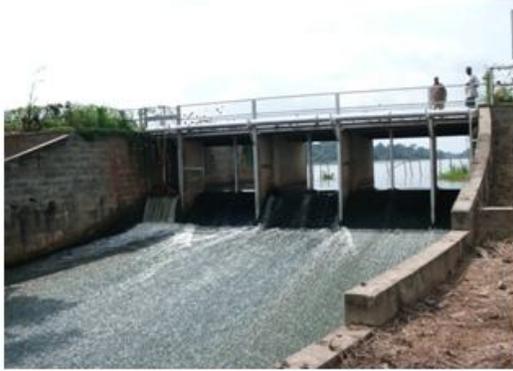
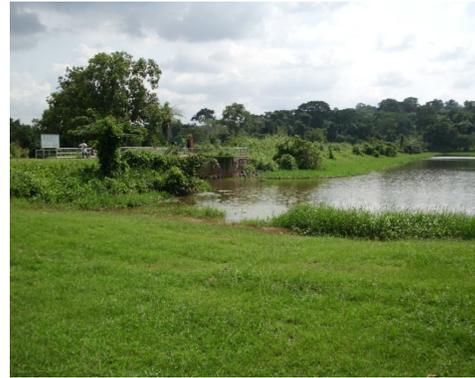
Reservoir/Dam	Type	Level of Damage	Operating efficiency
IITA	Free flow	No damage to the dam. The spillway was found operating normally and has effectively discharged the excess flood to the downstream river channel without damage to the spillway or the immediate downstream channel.  However, as a result of high winds that follow the rain storm, many trees were uprooted and many crops were damaged at some of experimental plots in the complex.	Said to be Okay
University of Ibadan	Free flow	Did not show any sign of stress as a result of the flood. The spillway was functioning normally and the downstream channel did not indicate an unusual flood	It was reported that the reservoir is silted up and its current capacity is not sufficient to meet the Institution water demand, hence supplementary supplies are received from the Eleyele reservoir.
Eleyele Reservoir/ Dam	Free flow	The dam was stable but the stilling basin and the downstream walls were damaged while the Waterworks was completely submerged as the water level downstream of the dam rose to about 2.4m above the channel floor. The station transformer, pump house, pumps, control panels and the clear water well were completely submerged for the duration of the flood event.	Restored to its original status

Fig. 4: The IITA Spillway and Dam Embankment after the Flood (7<sup>th</sup> September 2011)

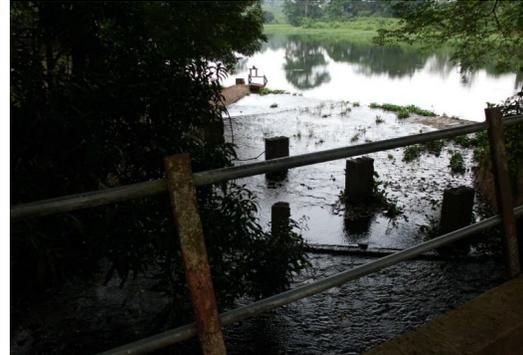
Fig. 5: The UI Dam Embankment and Spillway after the flood 6<sup>th</sup> September 2011

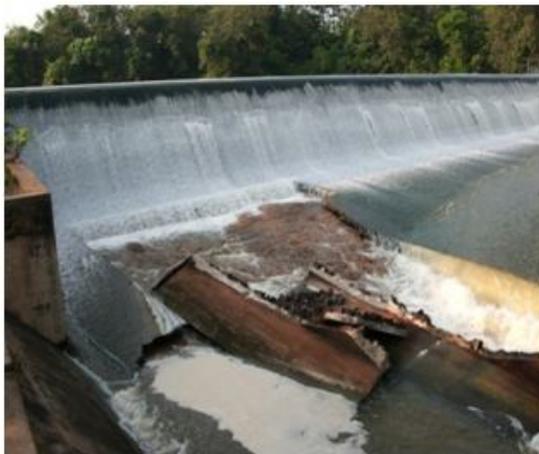
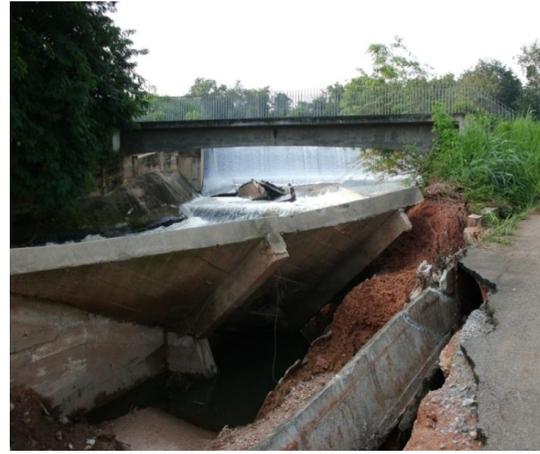
The level of damages on the floor of the stilling basin of Eleyele dam / Reservoir, downstream channel walls, culvert and the level of submergence of the downstream treatment plant testifies to the unusual nature of the runoff in volume and energy. However the spillway capacity is sufficiently adequate to allow the passage of the flood without threat to the dam and the spillway structures. The findings went contrary to the belief that the dams in the upper catchment gave up and were the cause of the unusual flow that causes the floods.

Fig. 6: The IITA Spillway and Dam Embankment after the Flood (7<sup>th</sup> September, 2011)

- c. Repair of the damaged section of the Spillway of the Eleyele dam should be given immediate priority to prevent another danger and loss of that dam and the services it provides.

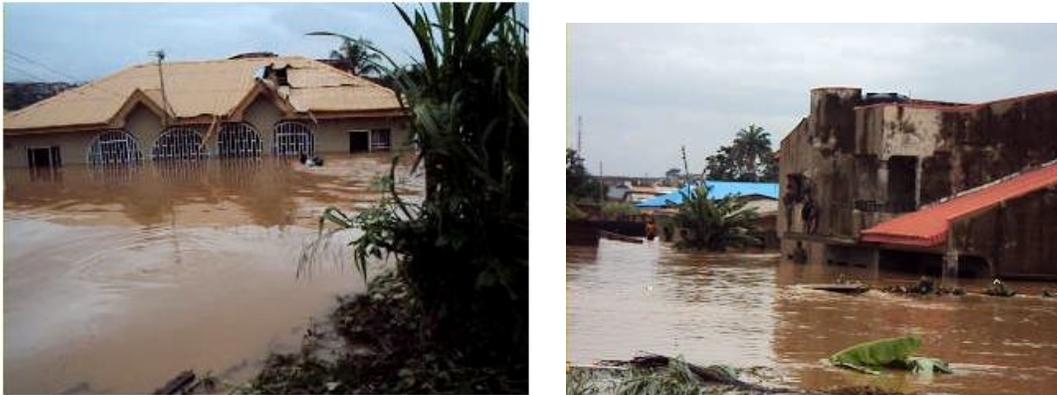
The flood wrecked havoc in the City particularly within the Ona River Basin. It washed off the Apete Bridge and overwhelms many bridges and culverts causing damages to the road and bridge / culvert structures at Ijokodo, Polytechnic road, Apata, Odo Ona Elewe and New

Garage, other place. Heap of garbage were seen deposited at the entrances of most of the bridges and culverts indicating that their capacities have been overwhelmed. Road pavements and the coal tar were peeled up and transported downstream thereby causing serious traffic disruptions. The Oluyole Power Holding Company of Nigeria (PHCN) substation, the fish ponds belonging to the Fisheries Department University of Ibadan, several residential houses were damaged and over 100 human lives were lost during the flood disaster. Figure 7 shows some of the properties damaged by the flood.

Fig. 7: Some cases of Property Submergence during the Flood
