Towards effective Hydrological Measurements downstream of Oyan dam

Abstract

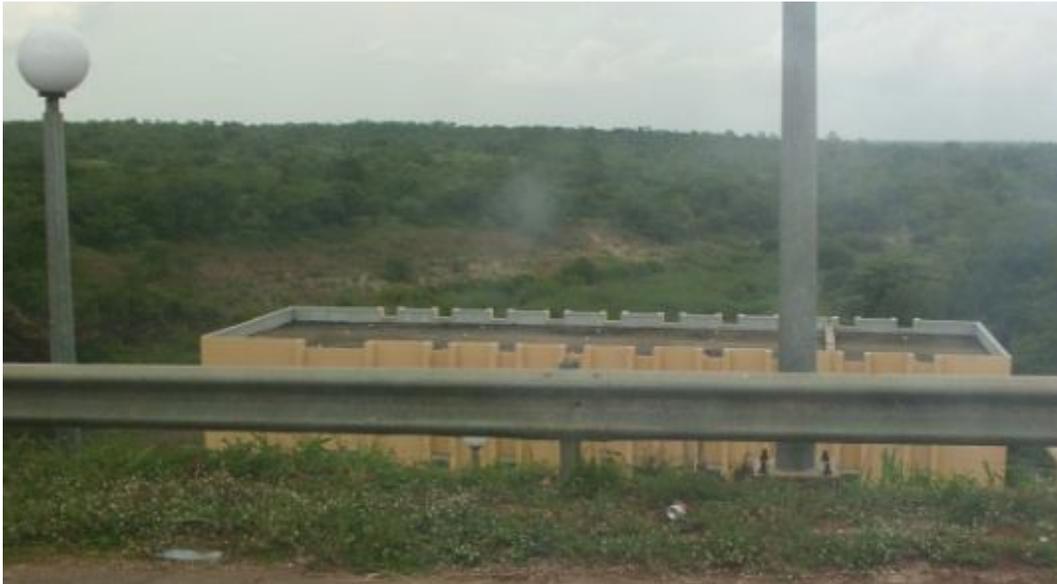
Figure 2: Power station at Oyan dam

Wikipedia(2010) documented that the Oyan River Dam was designed to supply raw water to Lagos and Abeokuta which are the immediate downstream urban cities, and to support the 3,000 hectare Lower Ogun Irrigation Project. Three turbines of 3 megawatts each were installed in 1983. Over the years, there had been cases of downstream flooding attributed to releases from the Oyan Dam. Other operational problems have also led to conflicts over the adequacy of water released for downstream uses: irrigation, fisheries and raw water supply for water treatment in Lagos state. The Oyan dam has a power house shown in Figure 2 for generating 9 MW of electricity and the Oyan reservoir also functions to control flood through safe releases downstream.

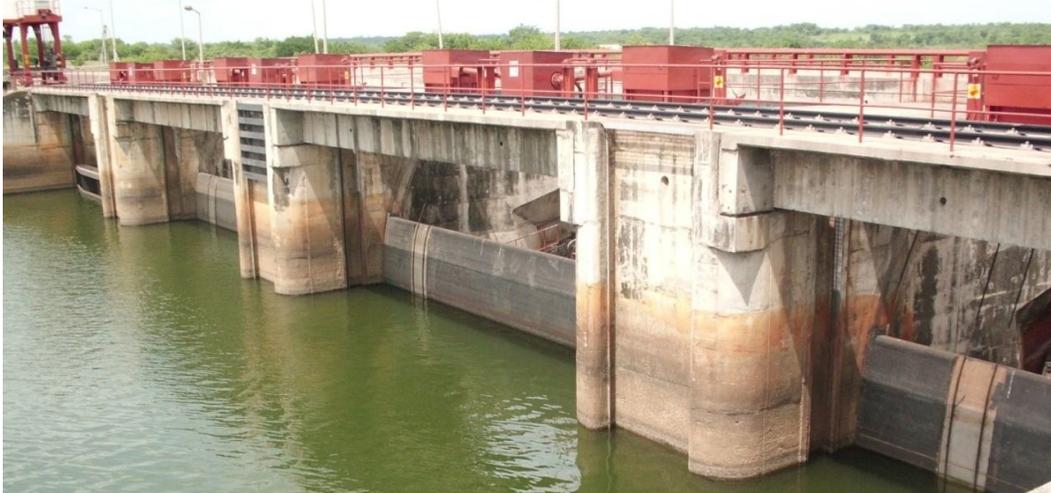
Figure 3: Spillway section at Oyan dam.

The Bench mark at the security gate of Oyan dam is located at 31 N 0528592 , E 0802661. The dam site elevation at this Bench mark was 85 m above mean sea level. Reservoir water level as at the time of visit at the Dam was 60.3 m. The downstream channel at the dam site was filled with water hyacinth and rock outcrops. The downstream flow was at the mercy of

the dam reservoir releases controlled by four (4) functional radial gates (Figure 3). Greenish vegetation was observed around the dam. The dam site was accessible but there was no suitable point for measurement along the river course before Alamutu Village. Upstream of the dam, land use activity was observed at left bank, while on the right bank evidence of some work done on a proposed irrigation scheme was noticeable.

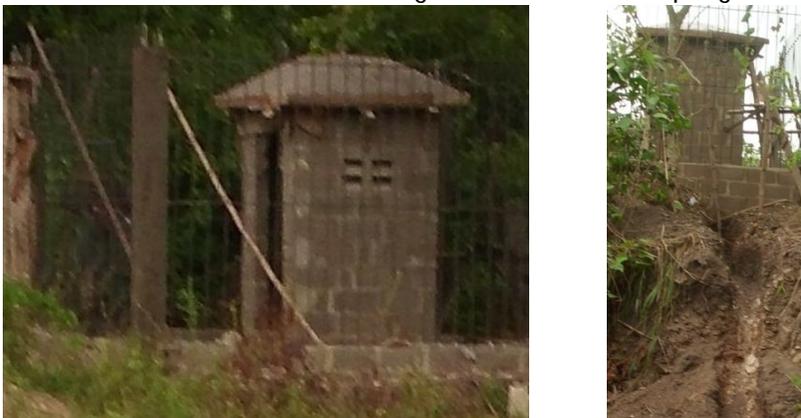
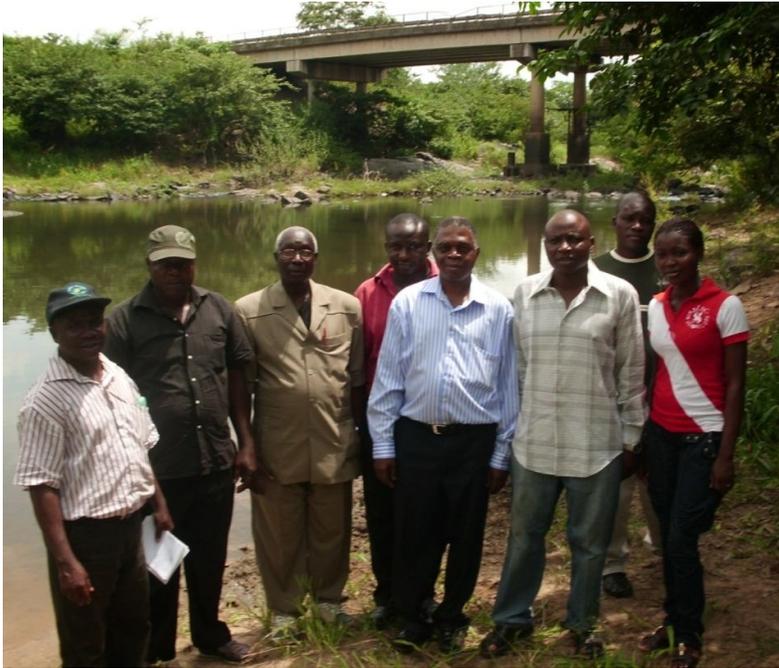
Here, the construction of housing for equipment on Early Flood Warning System was on-going (Figures 4 and 5). The elevation observed at this site (near the bridge on Abeokuta – Sokoto road) was 48 m. GPS positioning was (31 N 0532756 , E 0797800) Rock outcrops was observed within the channel. There was no existing hydrological station to record water level and none was being proposed, which if done may complement downstream observation. It was observed that the floodplain was very steep and soil surface bare, which may encourage soil erosion vis-à-vis sediment inflow to the river channel. It was discovered that installation of a new hydro station was being proposed by the OORBDA. The site was accessible and suitable for discharge and sediment sampling measurement.

Figure 4: Early Flood warning equipment housing under construction

Figure 5: Downstream Study Group at Oyan river below Early Flood warning equipment housing.

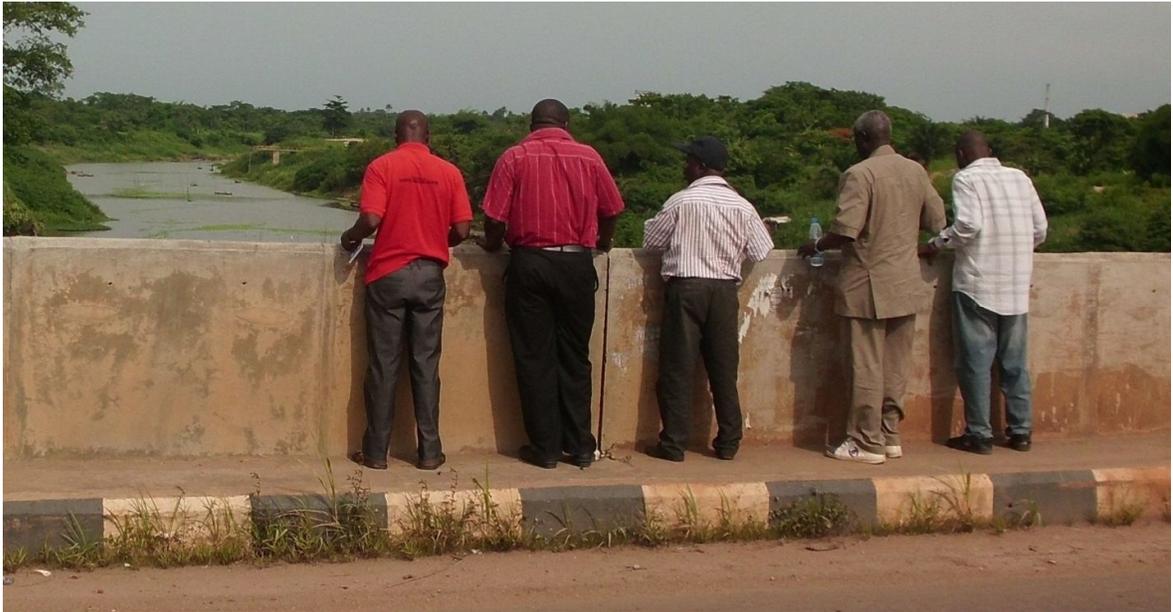
Figure 6: River Ogun at the bridge close to Mokoliki weir.

On a side of the bridge railings, the GPS positioning are (31 N 0541285, E 0760610) at an elevation 23 m. An ungated rectangular weir (Figure 6) with auxiliary side channel spillway was built on the river channel. Sandy bed was observed downstream of the bridge with attendant on-going sand mining activity both on the river channel and the floodplain. The ingenious miners created some secondary currents in the river by putting some obstructions under the bridge. This arrangement constrained the flow to go forward and turn back in a section of the river. In the process of turning back, the velocity reduces and more sediment settles in the river bed increasing the available sand to be mined. The reservoir behind the weir and the channel was infested with water hyacinth. Floodplain was dotted with green vegetation such as trees, plantain plantation and palm trees. There was no water level recorder at this site. Floodplain soil characteristic was clayey in nature, which could encourage mud turbidity during high runoff. Site accessibility was okay but would require bush clearing during the project execution. The site was suitable for measurement at downstream or upstream of the weir.

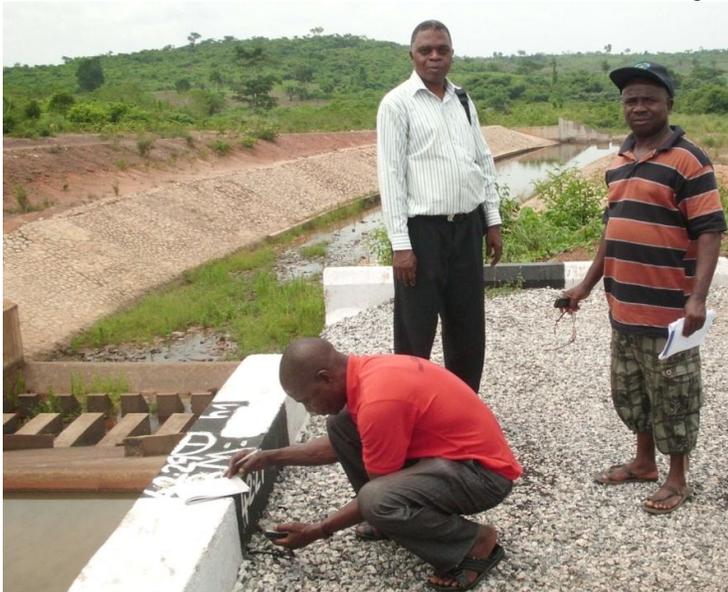
Figure 7: Spilway section of Owiwi dam

River Owiwi is a tributary of Ogun River. At Owiwi dam site (Figure 7), the study group visited water treatment site which supplies water to Owiwi communities and settlements near Abeokuta. The owiwi reservoir irrigates about 45 ha of land. Water level at the time of visit was 38.6 m. Bench mark was at 42.29 m. GPS readings were 31 N 0529551 , 0780599

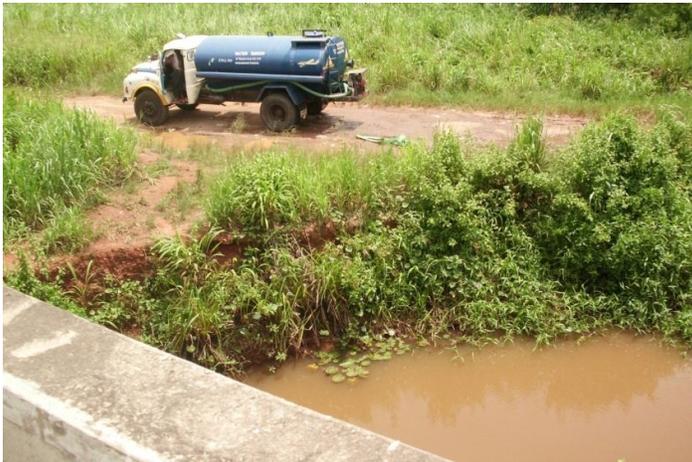
Figure 8: River Owiwi at the bridge on Abeokuta – Lagos road

The site is shown in Figure 8. . At this site accessibility was okay but the river width was very narrow. It was envisaged that suitable location for measurement could be found a little

further down of the bridge. No gauging station was seen, but BM of Owiwi dam site could be transferred to this site. The river channel was bushy and needed clearing. GPS readings were 31 N 0530874, 0779546, with an elevation of 40 m

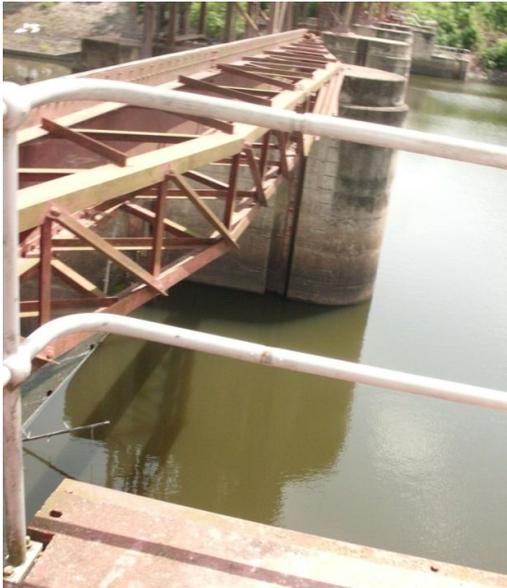
Figure 9: Weir at Iberekodo waterworks in Abeokuta

Iberekodo Water works was established in 1962 and equipped with five (5) vertical gates (Figure 9), supplying water to Abeokuta metropolis and its environs. Water level of reservoir as at the time of visit was 5.27 m. However, the visiting team was informed that the minimum operating tolerable level is 4.27 m. Anything below this level would hinder the water supply regimentation. This rather informed the frequent complaints of Lagos community of inadequate raw water supply at this critical water level at Iberekodo Waterworks. The channel downstream was dotted with rock outcrops which may hinder discharge measurement. Discharge measurements could be done further downstream or upstream of the waterworks. GPS readings were 31 N 0536617, 0794632 at an elevation of 48 m.

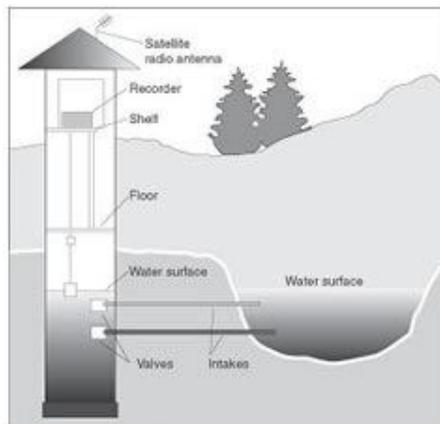
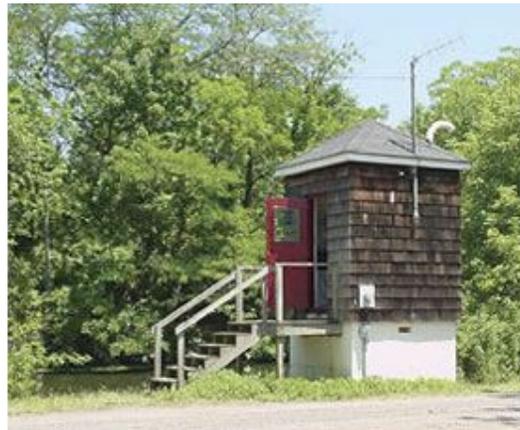
According to US Geological survey (2004), gauging stations are facilities used by hydrologists to automatically monitor streams, wells, lakes, canals, reservoirs and or other water bodies. Instruments at these stations collect information such as water height, discharge, water chemistry and water temperature. Figure 10 shows a schematic diagram of stilling well and shelter at a stream gauging station.

Figure 10: Schematic of a stilling well and shelter at a stream gauging station (USGS and NOAA, 2004).
