Analysis of Selected Failed Gully Erosion Control Works in Imo State

Special Publication of the Nigerian Association of Hydrological Sciences, 2012

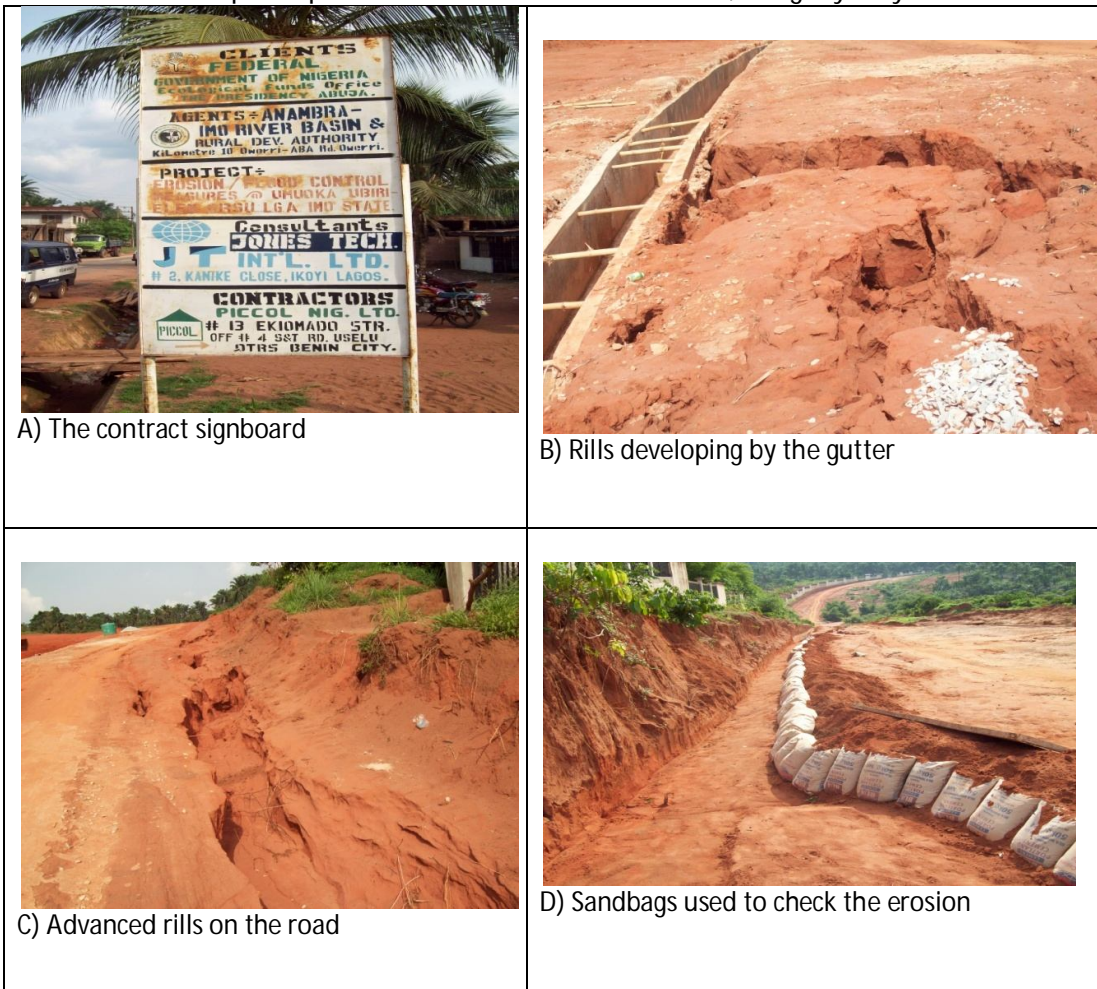
Figure 3: Umuoka Ubiri Elem erosion site

The gully in this site was mechanically bulldozed and flattened out down to the Azezie Asa river. Due to poor work done in terms of soil compaction and defective concrete channel (drainage length - 900m, depth - 1m, width-1m, thickness of concrete - 0.15m, no rip-rap, no groin, no armoury, no detention) rills have begun to develop measuring up to 700 m in length and 1.4 m in depth. Current effort at checking this erosion is the use of sandbags (Figure 3). The power of surface runoff was completely disregarded in this site. In no time, if urgent efforts are not put in place to control the surface runoff, the gully may resurface.
